**Flood Control Project Maintenance
Levee Inspections**
LMA District Cover Sheet
Spring 2020 Levee Inspection Results

Lower San Joaquin Levee District

Spring 2020 Levee Inspection Results

Waterway			Bank	Unit Miles
Unit No. 01 San Joaquin River			Right	22.52
	Spring (March - May)	Summer (June - August)	(September - November) Fall	Winter (December - February)
Unit Maintenance Rating (Fall Only)				
Date of Inspection	4/21/2020 - 4/21/2020			
DWR Inspector	Corey Fujitani			
Accompanied By

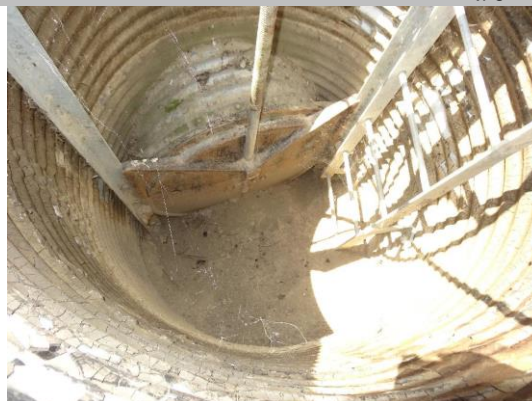
Photo 2 of 3 : UCIP_SP_2020_39468_66426.jpg

Comment Code					
Inspector Comment					
DS_ID:19830 FS_ID:39468 EP_NO: N/A Repair Type: Non-Urgent Crossing Status: Found UCIP Comments: 04/18/2014 Sediment buildup inside crossing visible from landward side. Recommend clearing sediment buildup inside pipe and check wall integrity to determine condition. (DWR UCIP - O. Magana) FIELD_STRUCT_DESC: 36-inch corrugated metal gravity drainage pipe through the levee, 6.9 feet below the crown. Slide gate in a 48-inch corrugated metal pipe (CMP) riser on the waterside (WS) slope. Concrete headwall on the landside (LS) end. Concrete saddle and apron on the WS end. [Additional Reference(s): DWR Levee Log, 2002. USACE San Joaquin O&M Manual 601.1, 1967, (HLM 4.70)]. FS Date: 4/18/2014

Inside view of CMP riser located on waterward.

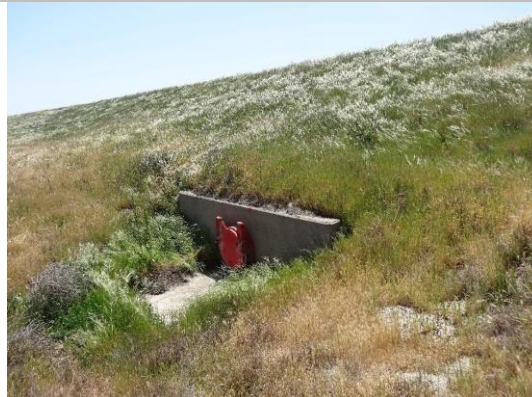
Photo 2 of 3 : UCIP_SP_2020_36609_66432.jpg

LM Start	4.67	Rating **	M	Issue No.	1228	
LM End	4.67	Issue Type +	Ma	Location *		
Category	Supplemental			GPS Latitude/Longitude		
				Start		End
Item	DWR UCIP LMA Responsibility			37.243408 °	37.243408 °	
				-120.760564 °	-120.760564 °	
DWR ID	19831					
Comment Code						
Inspector Comment						
DS_ID:19831 FS_ID:36609 EP_NO: N/A Repair Type: Non-Urgent Crossing Status: Found UCIP Comments: 04/18/2014 Need to contact owner. Recommend removing tall grass on landward toe to determine condition of crossing from landward side. (DWR UCIP - O. Magana) FIELD_STRUCT_DESC: 24-inch corrugated metal gravity drainage pipe through the levee, 11.8 feet below the crown. Flap gate on the waterside (WS) end. Concrete headwall on each end. [Additional Reference(s): DWR Levee Log, 2002. USACE San Joaquin O&M Manual 601.1, 1967, (HLM 4.75)]. FS Date: 4/18/2014

Flap gate, concrete headwall and apron visible on waterward toe.

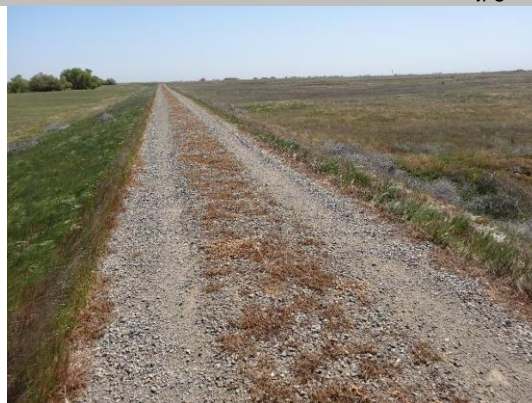
Photo 2 of 3 : UCIP_SP_2020_39875_61598.jpg

Overview of levee crown at crossing.

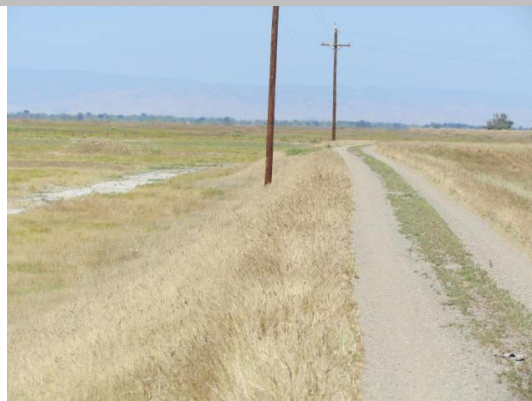
Photo 1 of 1 : SP_2020_NA0010_124_69_20200225_00018.jpg

LM Start	5.93	Rating **	M	Issue No.	69
LM End	6.25	Issue Type +	En	Location *	LS
Category	Earthen Levee			GPS Latitude/Longitude	
				Start	End
Item	Encroachments			37.236936 °	37.235487 °
				-120.740384 °	-120.737685 °
DWR ID	DWR_NA0010_06_f_2015_69				
Comment Code					
PO : Pole					
Inspector Comment					
There are several PG&E poles within this section at the landside toe and slope.

Looking west at several PG&E poles on landward slope.

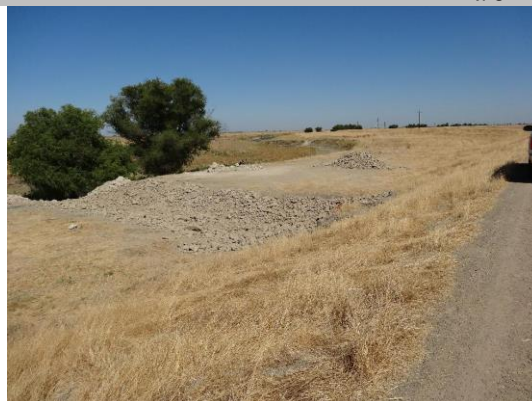
Photo 1 of 3 : UCIP_SP_2020_51312_75493.jpg

Comment Code						
Inspector Comment						
DS_ID:19865 FS_ID:51312 EP_NO: N/A Repair Type: No Action Needed Crossing Status: Found UCIP Comments: 7/19/2016 Site has been repaired on WS and LS (see photos below). (DWR UCIP - omagana)5/26/2016 Erosion is undermining the WS headwall of drainage structure (photos of WS headwall provided by DWR Inspector R. Willoughby). Potential pipe failure at the outlet just behind headwall, recommend completing internal wall integrity of pipe length through levee to determine extent of damage to pipe. (DWR UCIP - omagana)4/18/2014 Need to contact owner. Sediment buildup in pipe visible on landside--recommend clearing. (DWR UCIP - omagana) FIELD_STRUCT_DESC: 24-inch corrugated metal gravity drainage pipe through the levee, 9 feet below the crown. Flap gate on the waterside (WS) end. Concrete headwall on each end. [Additional Reference(s): DWR Levee Log, 2002. USACE San Joaquin O&M Manual 601.1, 1967, (HLM 6.06)]. FS Date: 7/19/2016

View of WS--rock protection along drainage path.

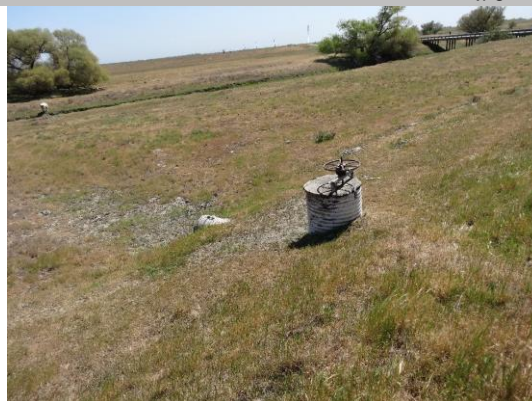
Photo 1 of 3 : UCIP_SP_2020_33984_61628.jpg

LM Start	6.70	Rating **	A/W	Issue No.	1233	
LM End	6.70	Issue Type +	Ma	Location *		
Category	Supplemental			GPS Latitude/Longitude		
				Start		End
Item	DWR UCIP LMA Responsibility			37.230508 °	37.230508 °	
				-120.729634 °	-120.729634 °	
DWR ID	19866					
Comment Code						
Inspector Comment						
DS_ID:19866						
FS_ID:33984						
EP_NO: N/A						
Repair Type: No Action Needed						
Crossing Status: Found						
UCIP Comments:						
FIELD_STRUCT_DESC: 24-inch corrugated metal gravity drainage pipe through the levee, 7 feet below the crown. Slide gate in a 36-inch corrugated metal pipe (CMP) riser on the waterside (WS) slope. Concrete headwall on the landside (LS) end. Concrete saddle and apron on the WS end. [Additional Reference(s): DWR Levee Log, 2002. USACE San Joaquin O&M Manual 601.1, 1967, (HLM 6.79)].						
FS Date: 4/18/2014

Slide gate inside CMP riser and pipe visible on waterward side.

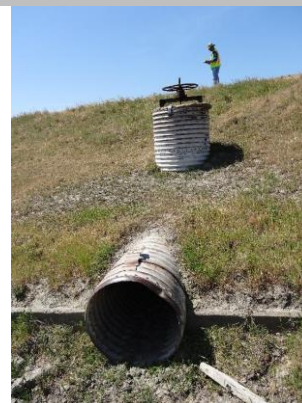
Photo 2 of 3 : UCIP_SP_2020_33984_61627.jpg

Concrete headwall visible on waterward side.

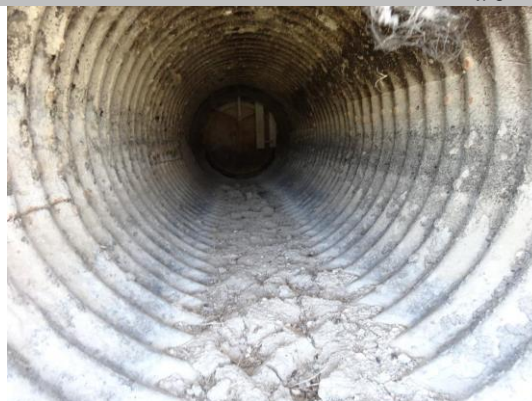
Photo 3 of 3 : UCIP_SP_2020_33984_61626.jpg

Inside view pipe from waterward side.

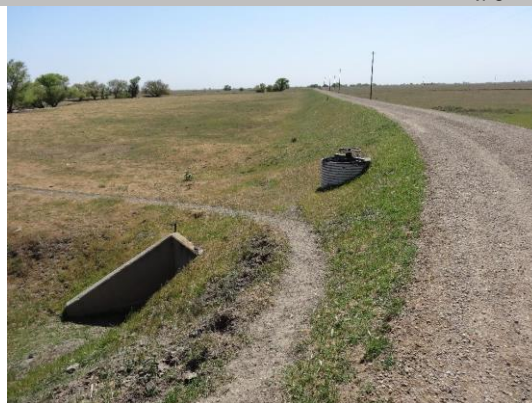
Photo 1 of 3 : UCIP_SP_2020_33985_61640.jpg

DS_ID:19867
 FS_ID:33985
 EP_NO: N/A
 Repair Type: No Action Needed
 Crossing Status: Found
 UCIP Comments:
 FIELD_STRUCT_DESC: 36-inch corrugated metal gravity drainage pipe through the levee, 10.7 feet below the crown. Slide gate in a 48-inch corrugated metal pipe (CMP) riser on the waterside (WS) slope. Concrete headwall on the landside (LS) end. Concrete U-shaped headwall on the WS end. [Additional Reference(s): DWR Levee Log, 2002. USACE San Joaquin O&M Manual 601.1, 1967, (HLM 6.97)].
 FS Date: 4/18/2014

View of waterward side.

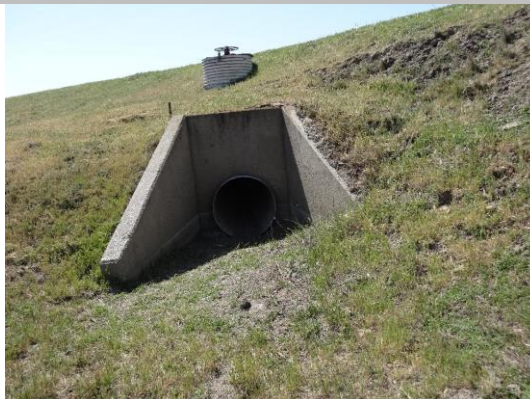
Photo 2 of 3 : UCIP_SP_2020_33985_61639.jpg

Concrete headwall and CMP riser visible on waterward side.

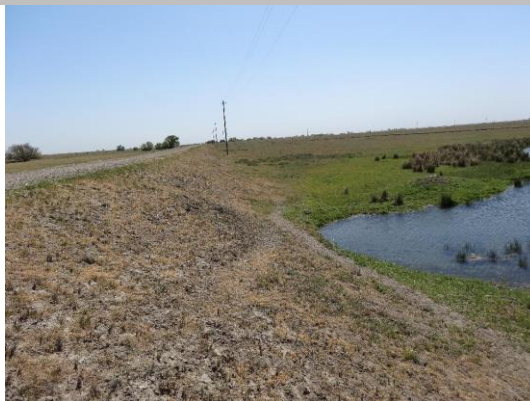
Photo 3 of 3 : UCIP_SP_2020_33985_61638.jpg

View of landward side.

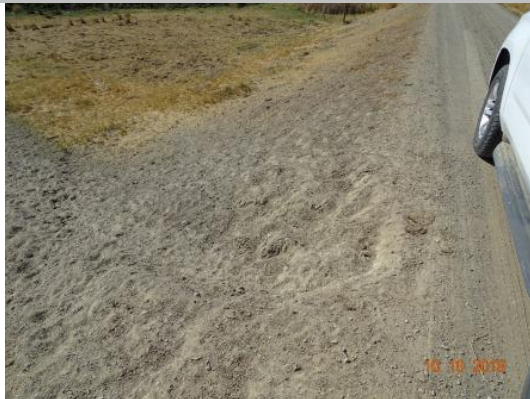
Photo 1 of 1 : SP_2020_NA0010_124_79_20200225_00025.jpg

LM Start	6.92	Rating **	A/W	Issue No.	79
LM End	6.92	Issue Type +	Ma	Location *	LS
Category	Earthen Levee			GPS Latitude/Longitude	
				Start	End
Item	Animal Control			37.228054 °	37.228054 °
				-120.727428 °	-120.727428 °
DWR ID	DWR_NA0010_06_f _ 2018_79				
Comment Code					
A2 : Repair the levee slope damaged by livestock and prevent large animal access.					
Inspector Comment					
There is livestock damage to slope and shoulder of levee.

Damage to slope and shoulder from livestock. (Fall 2018)

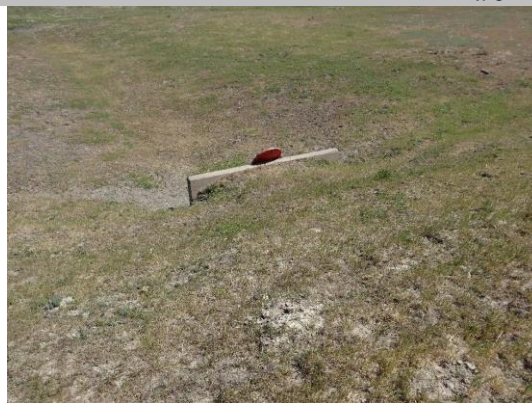
Photo 1 of 3 : UCIP_SP_2020_39471_61650.jpg

LM Start	7.21	Rating **	M	Issue No.	1235	
LM End	7.21	Issue Type +	Ma	Location *		
Category	Supplemental			GPS Latitude/Longitude		
				Start		End
Item	DWR UCIP LMA Responsibility			37.226102 °	37.226102 °	
				-120.722739 °	-120.722739 °	
DWR ID	19868					
Comment Code						
Inspector Comment						
DS_ID:19868 FS_ID:39471 EP_NO: N/A Repair Type: Non-Urgent Crossing Status: Found UCIP Comments: 04/18/2014 Need to contact owner. Clear animal from waterward side. Some sediment buildup in pipe visible landward side--recommend clearing. (DWR UCIP - O. Magana) FIELD_STRUCT_DESC: 24-inch corrugated metal gravity drainage pipe through the levee, 10.6 feet below the crown. Flap gate on the waterside (WS) end. Concrete headwall on each end. [Additional Reference(s): DWR Levee Log, 2002. USACE San Joaquin O&M Manual 601.1, 1967, (HLM 7.29)]. FS Date: 4/18/2014

View of waterward side.

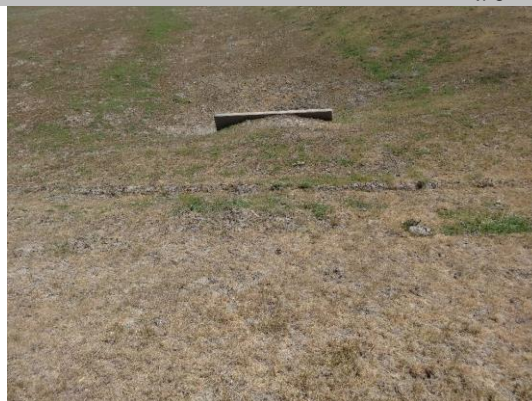
Photo 1 of 3 : UCIP_SP_2020_39472_66462.jpg

LM Start	7.66	Rating **	M	Issue No.	1236
LM End	7.66	Issue Type +	Ma	Location *	
Category	Supplemental			GPS Latitude/Longitude	
				Start	End
Item	DWR UCIP LMA Responsibility			37.222743 °	37.222743 °
				-120.716416 °	-120.716416 °
DWR ID	19869				
Comment Code					
Inspector Comment					
DS_ID:19869 FS_ID:39472 EP_NO: N/A Repair Type: Non-Urgent Crossing Status: Found UCIP Comments: 04/18/2014 Some sediment buildup in pipe visible on landward side--recommend clearing. (DWR UCIP - O. Magana) FIELD_STRUCT_DESC: 24-inch corrugated metal gravity drainage pipe through the levee, 11.8 feet below the crown. Flap gate on the waterside (WS) end. Concrete headwall on each end. Skewed crossing. [Additional Reference(s): DWR Levee Log, 2002. USACE San Joaquin O&M Manual 601.1, 1967, (HLM 7.74)]. FS Date: 4/18/2014

View of waterward side.

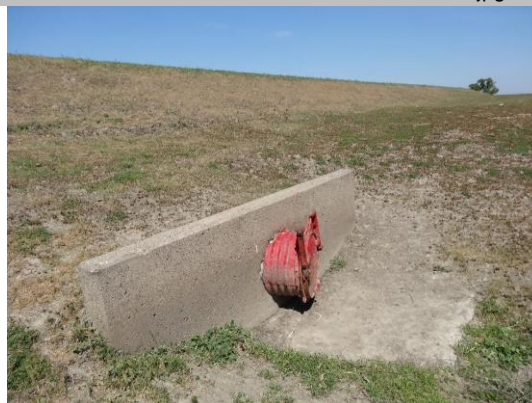
Photo 2 of 3 : UCIP_SP_2020_39472_66461.jpg

Pipe crosses levee at an angle.

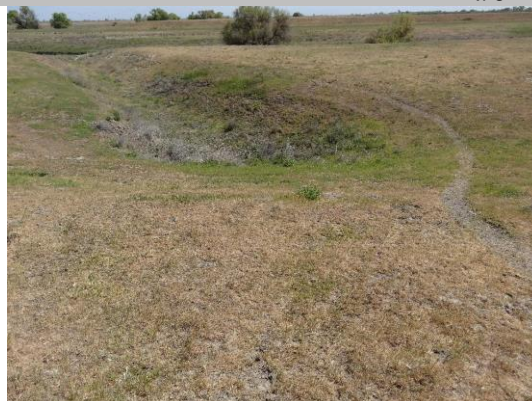
Photo 1 of 3 : UCIP_SP_2020_39473_61674.jpg

LM Start	8.13	Rating **	M	Issue No.	1237
LM End	8.13	Issue Type +	Ma	Location *	
Category	Supplemental			GPS Latitude/Longitude	
				Start	End
Item	DWR UCIP LMA Responsibility			37.216547 °	37.216547 °
				-120.713000 °	-120.713000 °
DWR ID	19870				
Comment Code					
Inspector Comment					
DS_ID:19870 FS_ID:39473 EP_NO: N/A Repair Type: Non-Urgent Crossing Status: Found UCIP Comments: 04/18/2014 Sediment buildup in pipe--recommend contacting owner to clear sediment. (DWR UCIP - O. Magana) FIELD_STRUCT_DESC: 24-inch corrugated metal gravity drainage pipe through the levee, 16.5 feet below the crown. Flap gate on the waterside (WS) end. Concrete headwall on each end. [Additional Reference(s): DWR Levee Log, 2002. USACE San Joaquin O&M Manual 601.1, 1967, (HLM 8.21)]. FS Date: 4/18/2014

View of waterward side.

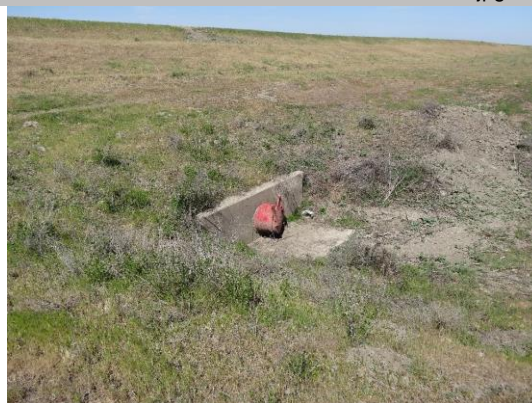
Photo 2 of 3 : UCIP_SP_2020_39473_61673.jpg

Pipe crosses levee at an angle.

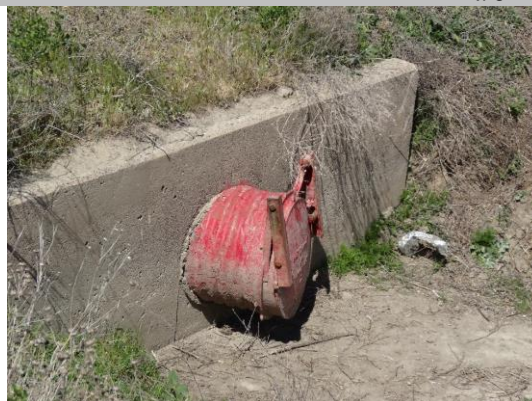
Photo 3 of 3 : UCIP_SP_2020_39473_61672.jpg

Concrete headwall and flap gate visible on waterward side.

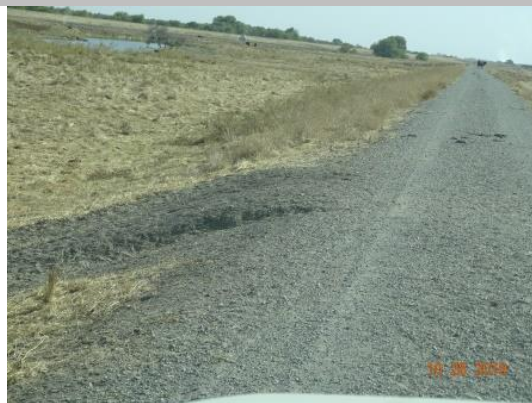
Photo 1 of 1 : SP_2020_NA0010_124_89_20200225_00036.jpg

LM Start	8.32	Rating **	M	Issue No.	89
LM End	8.32	Issue Type +	Ma	Location *	WS
Category	Earthen Levee			GPS Latitude/Longitude	
				Start	End
Item	Animal Control			37.214273 °	37.214273 °
				-120.711100 °	-120.711100 °
DWR ID	DWR_NA0010_06_f_2019_89				
Comment Code					
A2 : Repair the levee slope damaged by livestock and prevent large animal access.					
Inspector Comment					
Erosion from livestock traffic both sides of the levee.

View of damage to the waterside slope looking upstream. (Fall 2019)

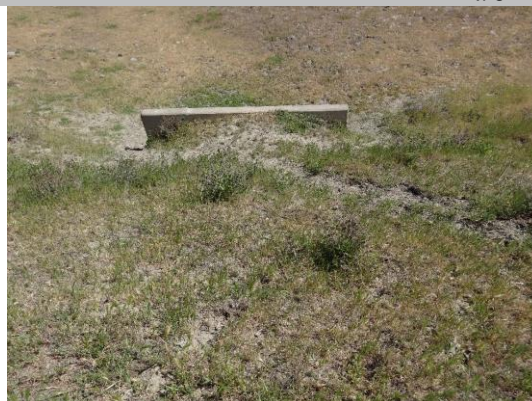
Photo 1 of 3 : UCIP_SP_2020_39474_61685.jpg

Comment Code						
Inspector Comment						
DS_ID:19871 FS_ID:39474 EP_NO: N/A Repair Type: Non-Urgent Crossing Status: Found UCIP Comments: 04/18/2014 Need to contact owner. Sediment buildup in pipe visible on landward side--recommend clearing. Good candidate for pressure test or video inspection due to signs of heavy corrosion. If no leaks after tests this crossing would be a good candidate for rehabilitation. (DWR UCIP - O. Magana) FIELD_STRUCT_DESC: 24-inch corrugated metal gravity drainage pipe through the levee, 9.2 feet below the crown. Flap gate on the waterside (WS) end. Concrete headwall on each end. [Additional Reference(s): DWR Levee Log, 2002. USACE San Joaquin O&M Manual 601.1, 1967, (HLM 8.51)]. FS Date: 4/18/2014

View of waterward side.

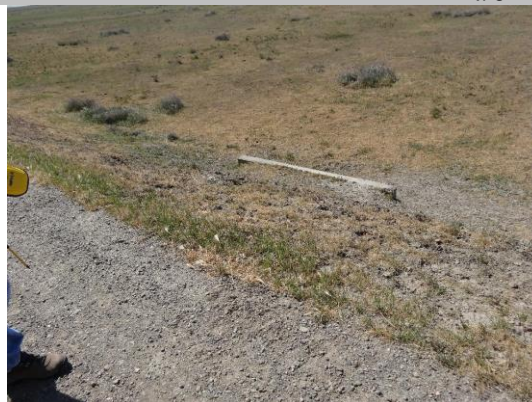
Photo 2 of 3 : UCIP_SP_2020_39474_61684.jpg

View of landward side.

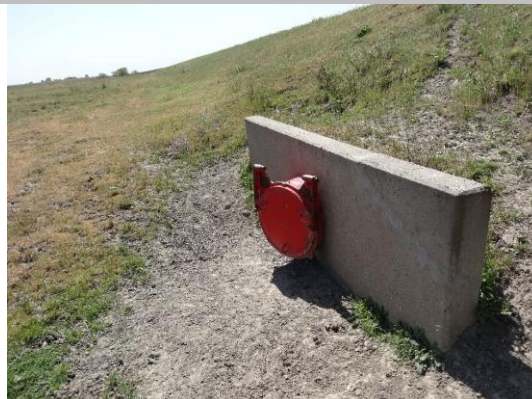
Photo 3 of 3 : UCIP_SP_2020_39474_61683.jpg

Pipe crosses levee at an angle.

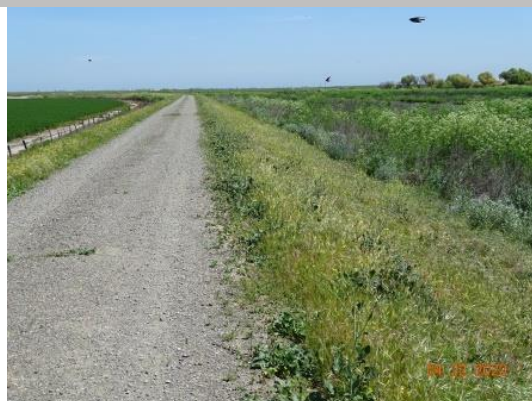
Photo 1 of 1 : SP_2020_NA0010_124_150_20200508_00212.jpg

LM Start	9.50	Rating **	U	Issue No.	150
LM End	19.22	Issue Type +	Ma	Location *	WS
Category	Earthen Levee			GPS Latitude/Longitude	
				Start	End
Item	Vegetation			37.202577 °	37.113708 °
				-120.695517 °	-120.588220 °
DWR ID	DWR_NA0010_06_s_2020_150				
Comment Code					
V1 : Control annual grass and weeds on the levee slopes and easements.					
Inspector Comment

View of vegetation on the waterside slope. (Spring 2020)

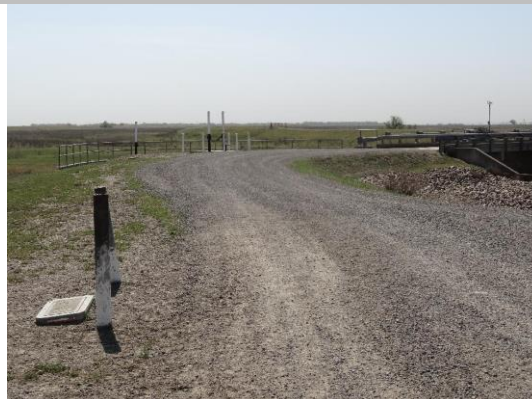
Photo 1 of 2 : UCIP_SP_2020_42525_72925.jpg

LM Start	9.52	Rating **	M	Issue No.	1239
LM End	9.52	Issue Type +	En	Location *	
Category	Supplemental			GPS Latitude/Longitude	
				Start	End
Item	DWR UCIP Field Study			37.202481 °	37.202481 °
				-120.695303 °	-120.695303 °
DWR ID	19872				
Comment Code					
Inspector Comment					
DS_ID:19872 FS_ID:42525 EP_NO: N/A Repair Type: Non-Urgent Crossing Status: Indicator Found UCIP Comments: 12/05/2014 Accidentally missed updating record. Photos have been added and coordinates have been updated. Unable to confirm if crossing is the same cable line originally identified in desk study at levee mile 6.43. Recommend contacting owner to confirm alignment, size of conduit, and permit issued. (DWR UCIP - O. Magana) FIELD_STRUCT_DESC: Telephone cable of an unknown size or material under crown of roadway, at an unknown depth. [Additional Reference(s): DWR Levee Log, 2002]. FS Date: 4/18/2014

Service box located on waterward levee shoulder.

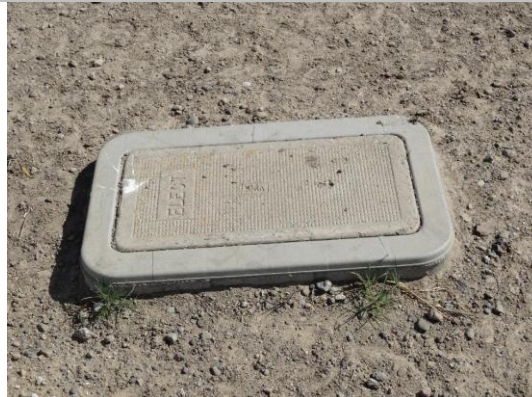
Photo 2 of 2 : UCIP_SP_2020_42525_72924.jpg

Service box is for electrical conduit.

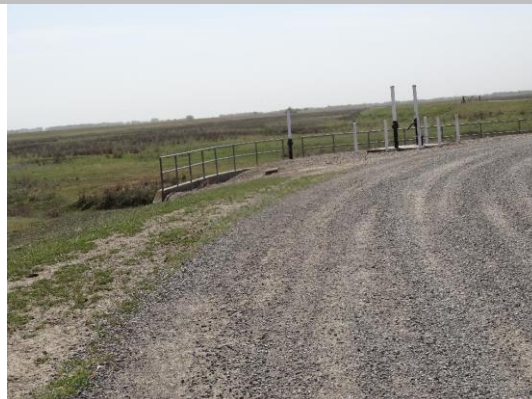
Photo 1 of 3 : UCIP_SP_2020_42524_72922.jpg

LM Start	9.56	Rating **	M	Issue No.	1240
LM End	9.56	Issue Type +	En	Location *	
Category	Supplemental			GPS Latitude/Longitude	
				Start	End
Item	DWR UCIP Field Study			37.202014 °	37.202014 °
				-120.694820 °	-120.694820 °
DWR ID	19873				
Comment Code					
Inspector Comment					
DS_ID:19873 FS_ID:42524 EP_NO: N/A Repair Type: Non-Urgent Crossing Status: Found UCIP Comments: 12/05/2014 Accidently missed entry. Photos have been added and coordinates have been updated by Olivia Magana. Unable to determine condition of crossing due to limited access. Recommend contacting owner to provide condition of crossing. (DWR UCIP - O. Magana) FIELD_STRUCT_DESC: 36-inch corrugated metal gravity drainage pipe through the levee, 14 feet below the crown. Slide gate in a concrete diversion box on the waterside (WS) shoulder. [Additional Reference(s): DWR Levee Log, 2002]. FS Date: 4/18/2014

Overview of levee crown looking upstream.

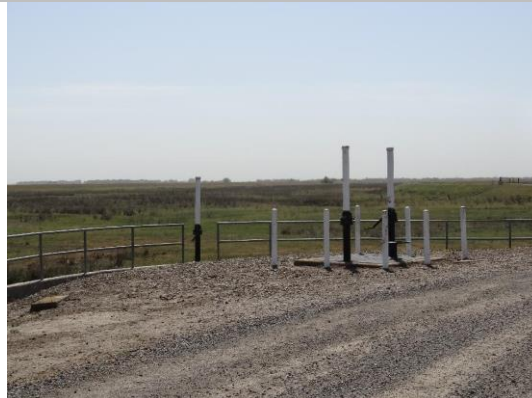
Photo 2 of 3 : UCIP_SP_2020_42524_72921.jpg

Concrete box located on waterward side.

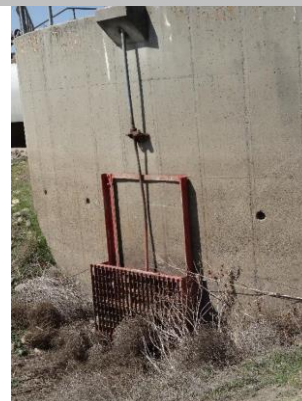
Photo 3 of 3 : UCIP_SP_2020_42524_72920.jpg

Trash gate visible on waterward side.

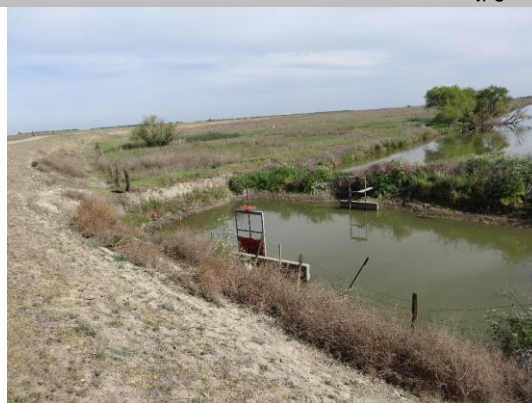
Photo 1 of 2 : UCIP_SP_2020_39475_61691.jpg

LM Start	9.66	Rating **	M	Issue No.	1246
LM End	9.66	Issue Type +	En	Location *	
Category	Supplemental			GPS Latitude/Longitude	
				Start	End
Item	DWR UCIP Field Study			37.200948 °	37.200948 °
				-120.694362 °	-120.694362 °
DWR ID	19874				
Comment Code					
Inspector Comment					
DS_ID:19874 FS_ID:39475 EP_NO: N/A Repair Type: Non-Urgent Crossing Status: Found UCIP Comments: 04/17/2014 Waterward side not visible--need to determine alignment. (DWR UCIP - O. Magana) FIELD_STRUCT_DESC: 36-inch corrugated metal gravity drainage pipe through the levee, 14 feet below the crown. Slide gate in a concrete diversion box on the waterside (WS) shoulder. [Additional Reference(s): DWR Levee Log, 2002]. FS Date: 4/17/2014

View of landward side.

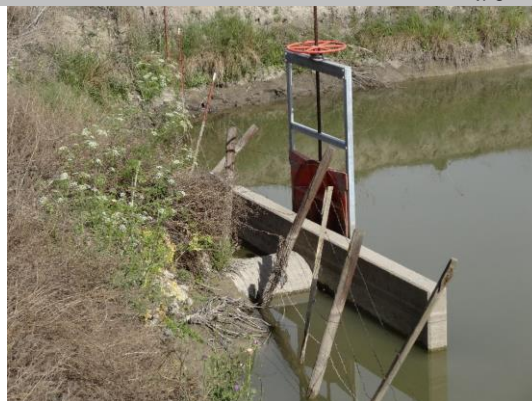
Photo 2 of 2 : UCIP_SP_2020_39475_61690.jpg

Pipe, slide gate, and concrete headwall visible on landward side.

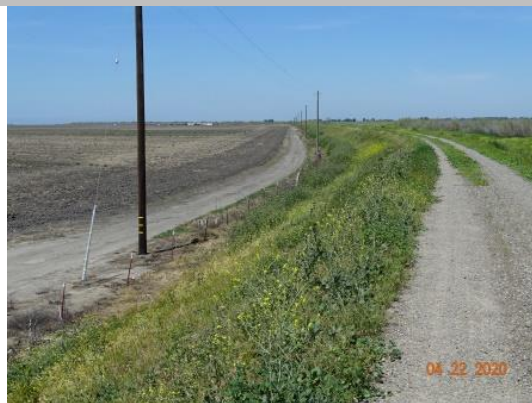
Photo 1 of 1 : SP_2020_NA0010_124_153_20200508_00213.jpg

LM Start	11.13	Rating **	U	Issue No.	153
LM End	16.40	Issue Type +	Ma	Location *	LS
Category	Earthen Levee			GPS Latitude/Longitude	
				Start	End
Item	Vegetation			37.186694 °	37.149837 °
				-120.674965 °	-120.607734 °
DWR ID	DWR_NA0010_06_s_2020_153				
Comment Code					
V1 : Control annual grass and weeds on the levee slopes and easements.					
Inspector Comment

View of the landside slope looking downstream. (Spring 2020)

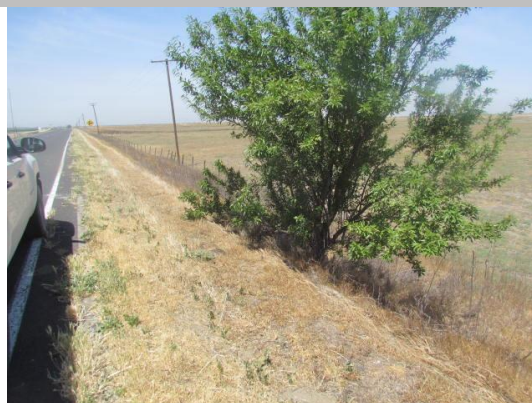
Photo 1 of 1 : SP_2020_NA0010_124_14_20200225_00010.jpg

LM Start	11.49	Rating **	M	Issue No.	14
LM End	11.49	Issue Type +	Ma	Location *	WS
Category	Earthen Levee			GPS Latitude/Longitude	
				Start	End
Item	Trim / Thin Trees			37.186189 °	37.186189 °
				-120.668476 °	-120.668476 °
DWR ID	DWR_NA0010_06_s_2015_14				
Comment Code					
T1 : Trim trees to at least five feet above ground level.					
Inspector Comment					
Almond tree located along Sandy Mush Road on waterside slope.

Looking west at tree on waterward slope.

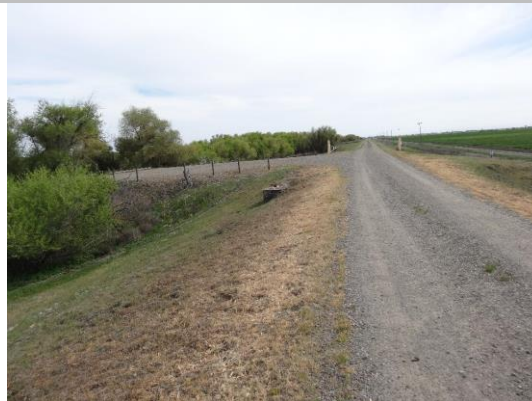
Photo 1 of 3 : UCIP_SP_2020_39476_66488.jpg

LM Start	11.74	Rating **	M	Issue No.	1248
LM End	11.74	Issue Type +	Ma	Location *	
Category	Supplemental			GPS Latitude/Longitude	
				Start	End
Item	DWR UCIP LMA Responsibility			37.185513 °	37.185513 °
				-120.664561 °	-120.664561 °
DWR ID	19876				
Comment Code					
Inspector Comment					
DS_ID:19876					
FS_ID:39476					
EP_NO: N/A					
Repair Type: Non-Urgent					
Crossing Status: Found					
UCIP Comments: 04/17/2014 Clear debris from waterward and landward toes. (DWR UCIP - O. Magana)					
FIELD_STRUCT_DESC: 36-inch corrugated metal gravity drainage pipe through the levee, 17 feet below the crown. Slide gate in a pipe riser on the waterside (WS) slope. [Additional Reference(s): DWR Levee Log, 2002. USACE San Joaquin O&M Manual 601.1, 1967, (HLM 11.82)].					
FS Date: 4/17/2014

View of waterward side.

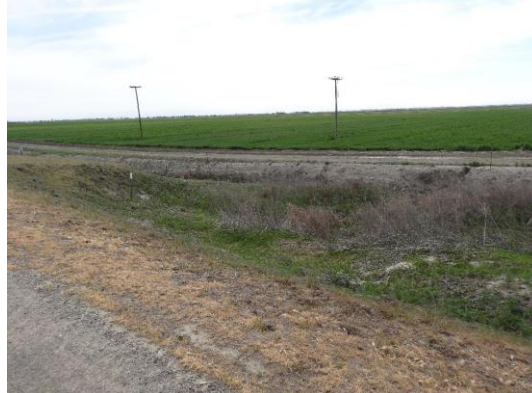
Photo 2 of 3 : UCIP_SP_2020_39476_66487.jpg

View of landward side.

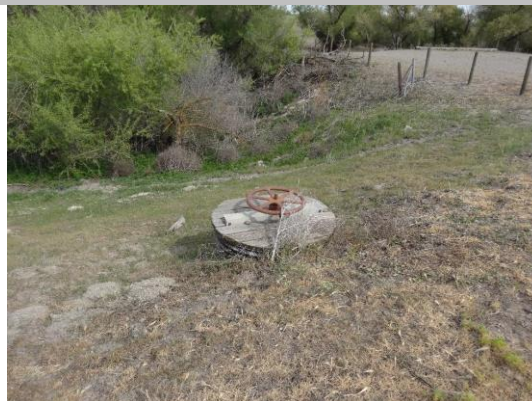
Photo 3 of 3 : UCIP_SP_2020_39476_66486.jpg

Slide gate inside CMP riser located on waterward slope.

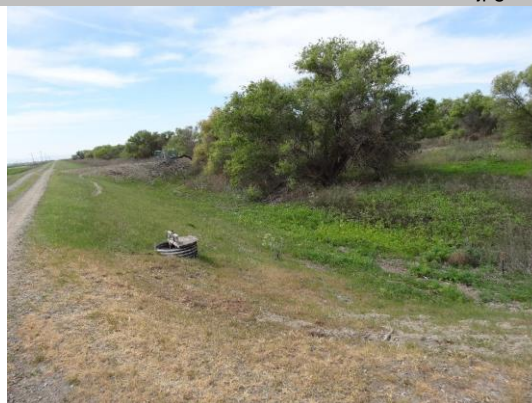
Photo 2 of 3 : UCIP_SP_2020_39477_66494.jpg

View of waterward slope.

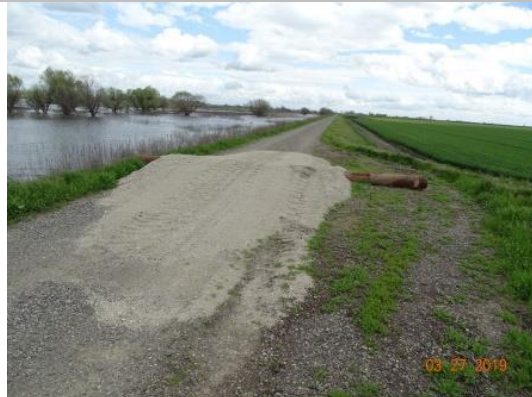
Photo 1 of 1 : SP_2020_NA0010_124_116_20200225_00057.jpg

LM Start	13.48	Rating **	A/W	Issue No.	116
LM End	13.48	Issue Type +	En	Location *	CR
Category	Earthen Levee			GPS Latitude/Longitude	
				Start	End
Item	Encroachments			37.171651 °	37.171651 °
				-120.650354 °	-120.650354 °
DWR ID	DWR_NA0010_06_s_2019_116				
Comment Code					
PI : Pipe					
Inspector Comment					
Landowner or farmer installed a pipe across levee crown.

View of pipe encroachment looking upstream. (Spring 2019)

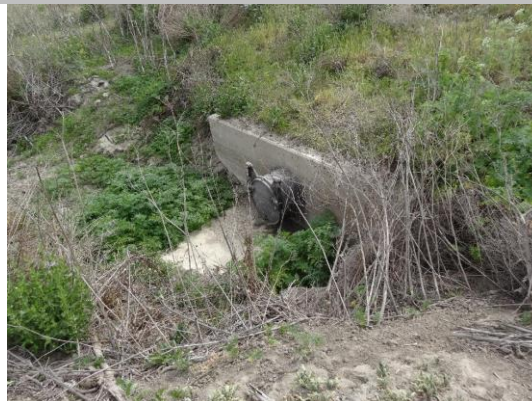
Photo 2 of 3 : UCIP_SP_2020_39478_66497.jpg

View of pipe daylight, flap gate, and concrete headwall visible on waterward toe.

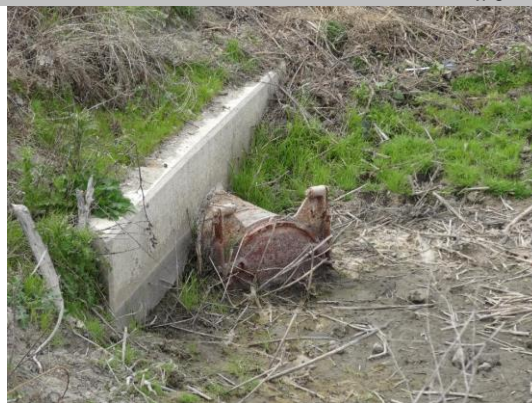
Photo 1 of 3 : UCIP_SP_2020_39480_66507.jpg

LM Start	15.68	Rating **	M	Issue No.	1251	
LM End	15.68	Issue Type +	Ma	Location *		
Category	Supplemental			GPS Latitude/Longitude		
				Start		End
Item	DWR UCIP LMA Responsibility			37.156934 °	37.156934 °	
				-120.617210 °	-120.617210 °	
DWR ID	19884					
Comment Code						
Inspector Comment						
DS_ID:19884 FS_ID:39480 EP_NO: N/A Repair Type: Non-Urgent Crossing Status: Found UCIP Comments: 04/17/2014 Need to contact owner. Sediment buildup on both the waterward and landward side. Recommend removing sediment buildup from both side. Also recommend clearing excess sediment inside crossing. (DWR UCIP - O. Magana) FIELD_STRUCT_DESC: 24-inch corrugated metal gravity drainage pipe through the levee, 14 feet below the crown. Flap gate on the waterside (WS) end. [Additional Reference(s): DWR Levee Log, 2002. USACE San Joaquin O&M Manual 601.1, 1967, (HLM 15.76)]. FS Date: 4/17/2014

Flap gate buried halfway on waterward side.

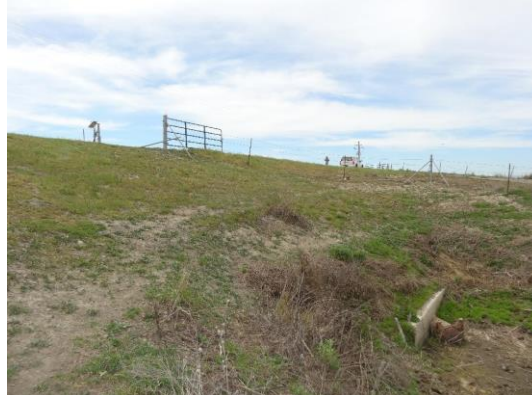
Photo 2 of 3 : UCIP_SP_2020_39480_66506.jpg

View of waterward side.

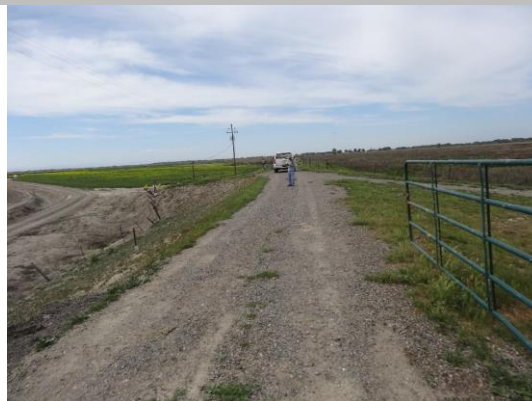
Photo 3 of 3 : UCIP_SP_2020_39480_66505.jpg

LM Start	15.68	Rating **	M	Issue No.	1251 (cont)
LM End	15.68	Issue Type +	Ma	Location *

Overview of levee crown at crossing.

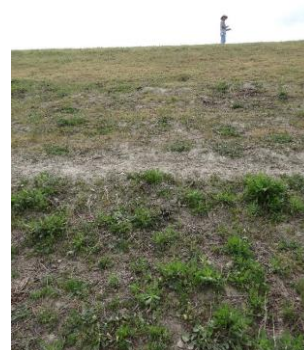
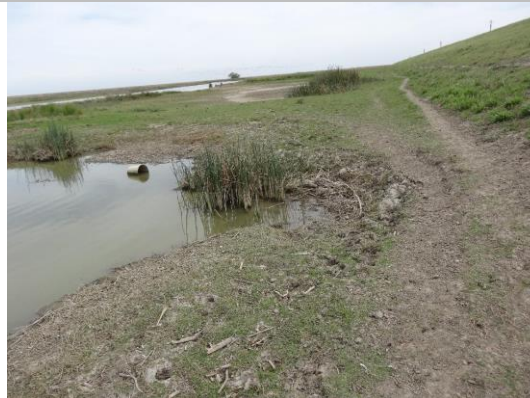
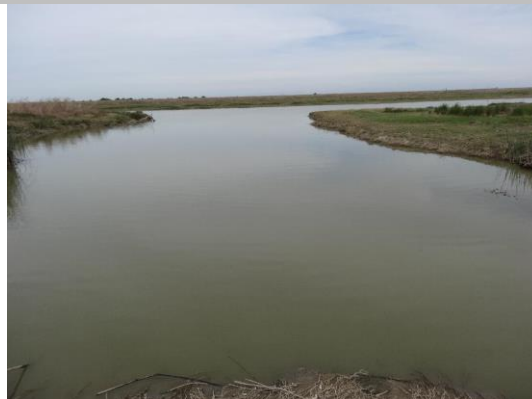
Comment Code						
Inspector Comment						
DS_ID:19885 FS_ID:36663 EP_NO: N/A Repair Type: Non-Urgent Crossing Status: Found UCIP Comments: 04/17/2014 Need to contact owner to determine status of crossing. Waterward side is buried and not accessible. Landward side headwall is blocked by dense vegetation. Recommend confirming status of flap gate on waterward side and removing dense vegetation form landward side. (DWR UCIP - O. Magana) FIELD_STRUCT_DESC: 36-inch corrugated metal gravity drainage pipe through the levee, 16.6 feet below the crown. Flap gate on the waterside (WS) end. [Additional Reference(s): DWR Levee Log, 2002. USACE San Joaquin O&M Manual 601.1, 1967, (HLM 15.91)]. FS Date: 4/17/2014

View of waterward side, Photo 1 of 3.

View of waterward side, photo 2 of 3.

View of waterward side, photo 3 of 3.

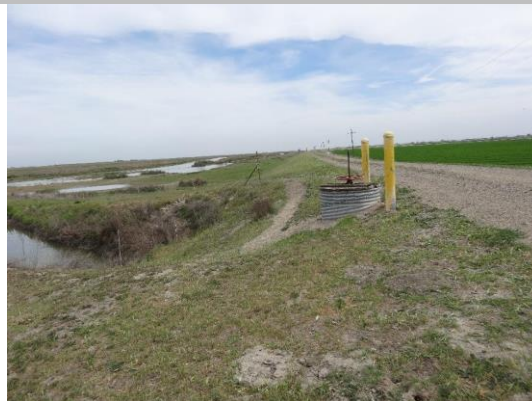
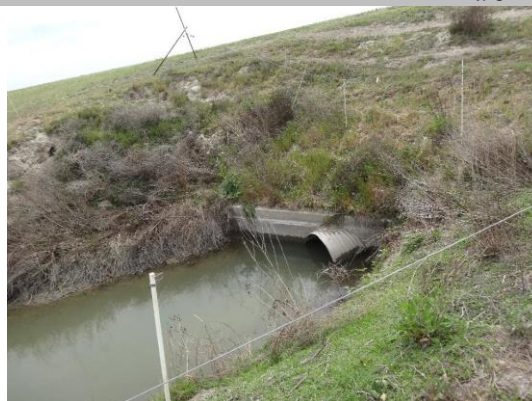
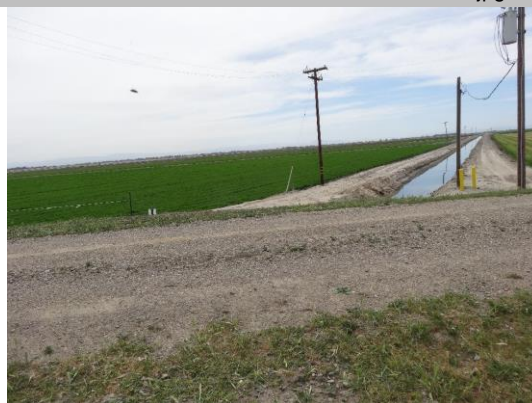
LM Start	16.40	Rating **	M	Issue No.	1253
LM End	16.40	Issue Type +	En	Location *	
Category	Supplemental			GPS Latitude/Longitude	
				Start	End
Item	DWR UCIP Field Study			37.149747 °	37.149747 °
				-120.607702 °	-120.607702 °
DWR ID	19559				
Comment Code					
Inspector Comment					
DS_ID:19559 FS_ID:36665 EP_NO: N/A Repair Type: Non-Urgent Crossing Status: Found UCIP Comments: 04/17/2014 Need to contact owner to determine status of crossing. Unable to confirm pipe diameter. (DWR UCIP - O. Magana) FIELD_STRUCT_DESC: 36-inch corrugated metal irrigation siphon pipe through the levee, 5.9 feet below the crown. Slide gate on the waterside (WS). Siphon extends under channel. [Additional Reference(s): USACE San Joaquin O&M Manual 601.1, 1967, (HLM 16.49)]. FS Date: 4/17/2014

View of waterward side.

Concrete headwall and pipe visible on waterward side.

View of landward side, photo 1 of 2.

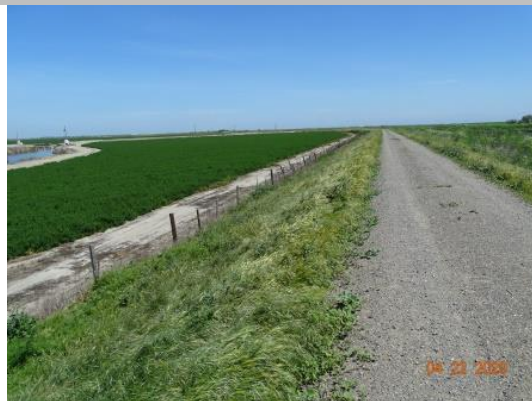
Photo 1 of 1 : SP_2020_NA0010_124_151_20200508_00214.jpg

LM Start	16.57	Rating **	U	Issue No.	151
LM End	19.22	Issue Type +	Ma	Location *	LS
Category	Earthen Levee			GPS Latitude/Longitude	
				Start	End
Item	Vegetation			37.147889 °	37.113707 °
				-120.605914 °	-120.588220 °
DWR ID	DWR_NA0010_06_s_2020_151				
Comment Code					
V1 : Control annual grass and weeds on the levee slopes and easements.					
Inspector Comment

Looking downstream along the landside slope. (Spring 2020)

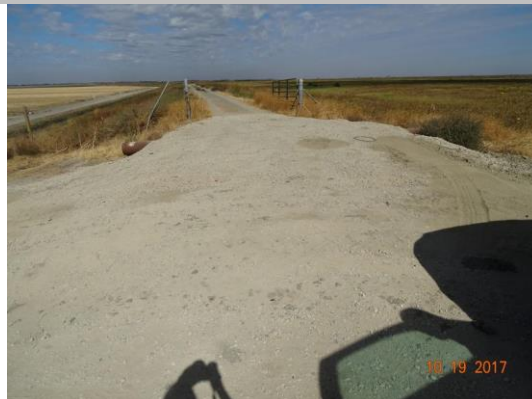
Photo 1 of 1 : SP_2020_NA0010_124_72_20200225_00021.jpg

LM Start	18.18	Rating **	A/W	Issue No.	72
LM End	18.18	Issue Type +	En	Location *	CR
Category	Earthen Levee			GPS Latitude/Longitude	
				Start	End
Item	Encroachments			37.127982 °	37.127982 °
				-120.590911 °	-120.590911 °
DWR ID	DWR_NA0010_06_f _ 2017_72				
Comment Code					
PI : Pipe					
Inspector Comment					
Non permitted pipe across the levee crown.

Looking northwest at the pipe across the levee crown. (Fall 2017)

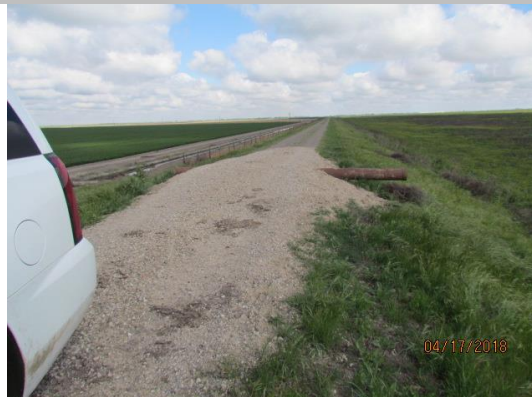
Photo 1 of 1 : SP_2020_NA0010_124_70_20200225_00019.jpg

LM Start	18.46	Rating **	A/W	Issue No.	70
LM End	18.46	Issue Type +	En	Location *	CR
Category	Earthen Levee			GPS Latitude/Longitude	
				Start	End
Item	Encroachments			37.124088 °	37.124088 °
				-120.589249 °	-120.589249 °
DWR ID	DWR_NA0010_06_s_2018_70				
Comment Code					
PI : Pipe					
Inspector Comment					
Landowner or farmer installed a pipe across levee crown.

Looking south at pipe across levee crown. (Spring 2018)

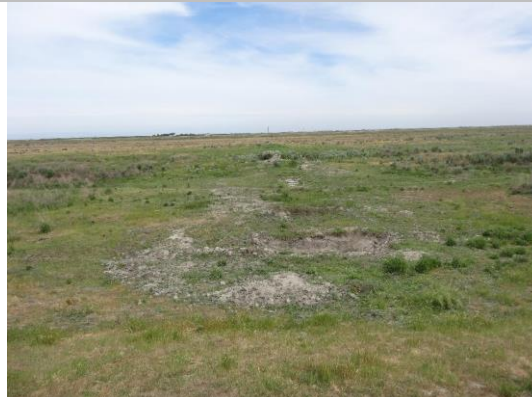
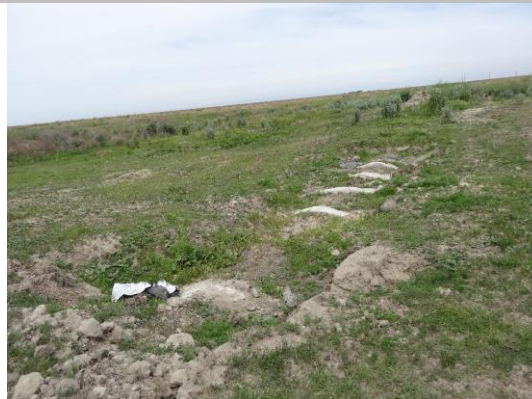
Comment Code					
Inspector Comment					
DS_ID:19888 FS_ID:53191 EP_NO: 3040 Repair Type: Urgent Crossing Status: Found UCIP Comments: 11/01/2018 Signs of pipe leakage (wet spot) visible in floodway. Crossing remains Urgent due to potential leakage along the pipe. Recommend internal inspection to determine pipe integrity through the levee. (O. Magana - DWR UCIP)07/20/2016 Same as previous inspection. Dense vegetation prevents proper inspection along floodway. (DWR UCIP - omagana)04/17/2014 Need to contact owner. Leak on waterward toe approximately 15 feet from toe. Good candidate for video or pressure test. (DWR UCIP - omagana) FIELD_STRUCT_DESC: 48-inch corrugated metal irrigation siphon pipe through the levee, 8.8 feet below the crown. Slide gate in a pipe riser on the landside (LS) slope, not the waterside (WS) slope. Concrete headwall on the LS, not the WS. Siphon extends under the channel. 24-inch corrugated metal cleanout pipe at the center of the channel with a metal plate cover. (Plans for construction of two reinforced concrete siphons across the Eastside Bypass authorized under Permit No. 3040, 1959 - Newhall Land and Farming Company). [Additional Reference(s): DWR Levee Log, 2002. USACE San Joaquin O&M Manual 601.1, 1967, (HLM 18.91)]. FS Date: 11/1/2018 12:52:00 PM

View of WS. Channel section exposed near waterward toe.

Overview of Eastside Bypass.

Channel sections have been excavated across Eastside Bypass.

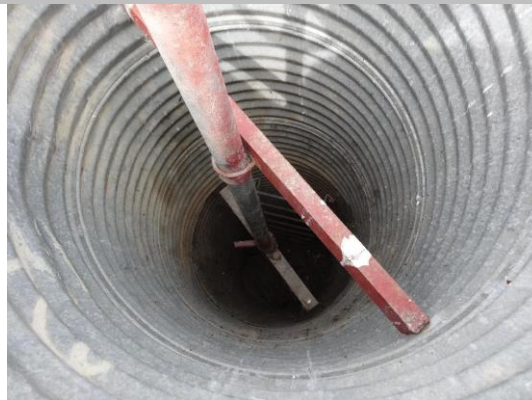
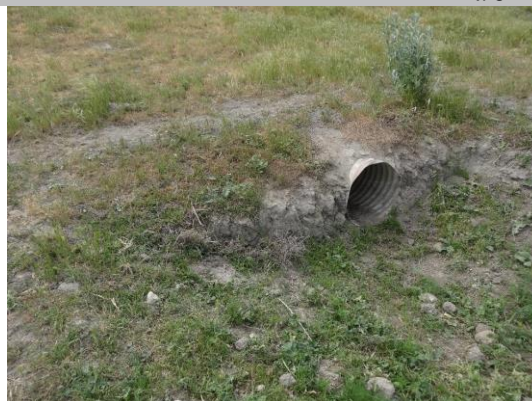
Comment Code						
Inspector Comment						
DS_ID:19889 FS_ID:36687 EP_NO: N/A Repair Type: Non-Urgent Crossing Status: Found UCIP Comments: 04/17/2014 Dense vegetation limits the inspector's visibility to identify signs of pipe failure (leaks) along the landward slope. Recommend removing vegetation along pipe alignment to conduct proper inspection of structure. (DWR UCIP - O. Magana) FIELD_STRUCT_DESC: 24-inch corrugated metal gravity drainage pipe through the levee, 10.2 feet below the crown. Slide gate in a pipe riser on the waterside (WS) slope. [Additional Reference(s): DWR Levee Log, 2002. USACE San Joaquin O&M Manual 601.1, 1967, (HLM 18.97)]. FS Date: 4/17/2014

View of waterward side.

Inside view of CMP riser located on waterward slope.

Pipe daylight on waterward side.

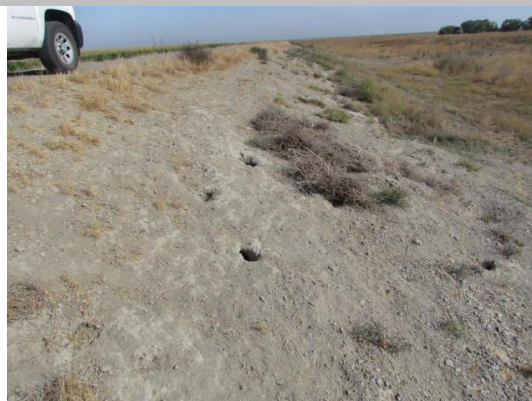
Photo 1 of 1 : SP_2020_NA0010_124_1211_20200225_00075.jpg

LM Start	19.14	Rating **	U	Issue No.	1211
LM End	19.14	Issue Type +	Ma	Location *	WS
Category	Earthen Levee			GPS Latitude/Longitude	
				Start	End
Item	Animal Control			37.114793 °	37.114793 °
				-120.587582 °	-120.587582 °
DWR ID	DWR_NA0010_06_s_2015_1211				
Comment Code					
A1 : Exterminate rodents and backfill and compact or grout burrows.					
Inspector Comment					
Several large rodent holes with more than 2 cubic feet of material were noted on the waterside slope.

Looking at several rodent holes on waterward slope. (Fall 2015)

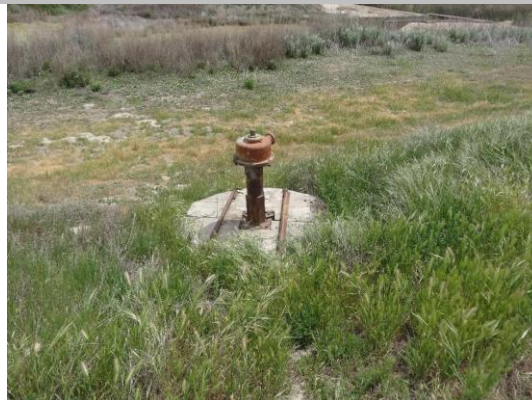
Comment Code						
Inspector Comment						
DS_ID:19890 FS_ID:36688 EP_NO: N/A Repair Type: Non-Urgent Crossing Status: Found UCIP Comments: 04/17/2014 Dense vegetation limits the inspector's visibility to identify signs of pipe failure (leaks) along the slopes. Recommend removing vegetation along pipe alignment to conduct proper inspection of structure. (DWR UCIP - O. Magana) FIELD_STRUCT_DESC: 48-inch corrugated metal gravity drainage pipe through the levee, 20 feet below the crown. Slide gate in a pipe riser on the waterside (WS) slope. Riprap along the landside (LS) slope. [Additional Reference(s): DWR Levee Log, 2002. USACE San Joaquin O&M Manual 601.1, 1967, (HLM 19.36)]. FS Date: 4/17/2014

View of waterward side.

Riser located on waterward slope.

View of landward slope.

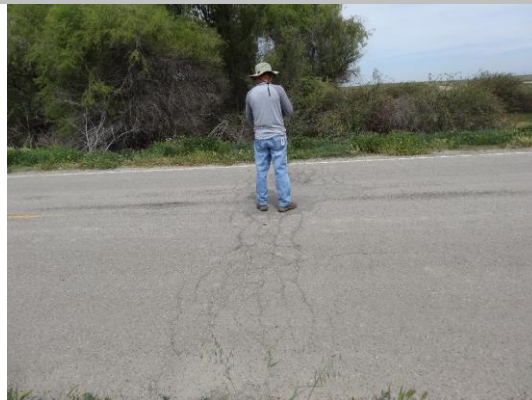
Comment Code						
Inspector Comment						
DS_ID:19891 FS_ID:36689 EP_NO: N/A Repair Type: Non-Urgent Crossing Status: Found UCIP Comments: 04/17/2014 Dense vegetation limits the inspector's visibility to identify signs of pipe failure (leaks) along the slopes. Recommend removing vegetation along pipe alignment to conduct proper inspection of structure. (DWR UCIP - O. Magana) FIELD_STRUCT_DESC: 30-inch by 30-inch reinforced concrete box gravity drainage culvert through the levee, 14 feet below the crown. Flap gate on the waterside (WS) end. [Additional Reference(s): DWR Levee Log, 2002. USACE San Joaquin O&M Manual 601.1, 1967, (HLM 19.85)]. FS Date: 4/17/2014

Overview of levee crown looking downstream.

View of levee crown at crossing.

View of "U" concrete headwall located on waterward side.

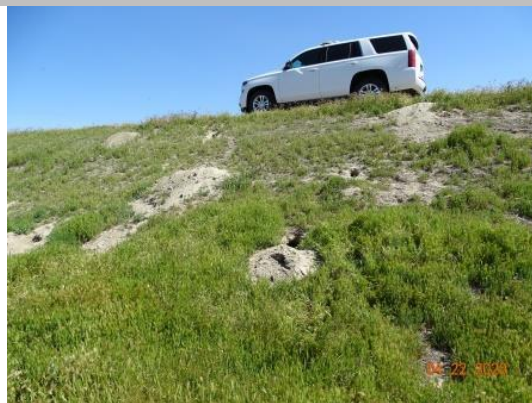
Photo 1 of 1 : SP_2020_NA0010_124_114_20200508_00216.jpg

LM Start	21.39	Rating **	M	Issue No.	114
LM End	21.39	Issue Type +	Ma	Location *	LS
Category	Earthen Levee			GPS Latitude/Longitude	
				Start	End
Item	Animal Control			37.106397 °	37.106397 °
				-120.556727 °	-120.556727 °
DWR ID	DWR_NA0010_06_f _ 2019_114				
Comment Code					
A3 : No rodents visible, but rodent burrows visible; need to backfill and compact or grout burrows.					
Inspector Comment

View of rodent burrows on the landside slope. (Spring 2020)

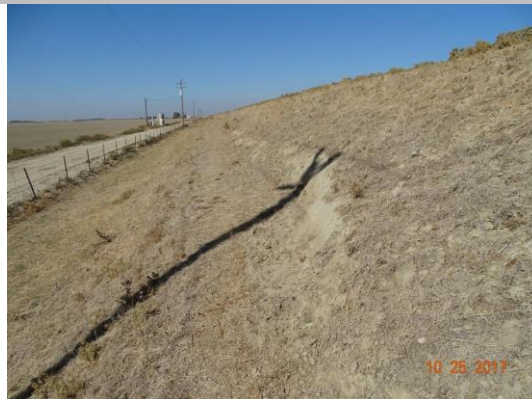
Photo 1 of 1 : SP_2020_NA0010_124_86_20200225_00033.jpg

LM Start	22.41	Rating **	M	Issue No.	86
LM End	22.46	Issue Type +	Ma	Location *	LS
Category	Earthen Levee			GPS Latitude/Longitude	
				Start	End
Item	Animal Control			37.094969 °	37.094479 °
				-120.544964 °	-120.544435 °
DWR ID	DWR_NA0010_06_f_2017_86				
Comment Code					
A2 : Repair the levee slope damaged by livestock and prevent large animal access.					
Inspector Comment					
Erosion greater than 3 inches on landside slope caused by livestock.

Looking northwest at the landside slope.

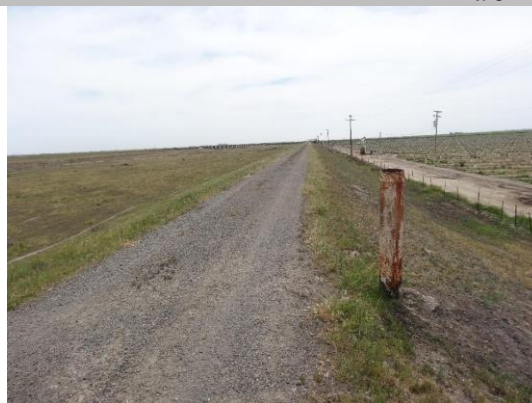
Photo 1 of 3 : UCIP_SP_2020_34010_61871.jpg

Comment Code						
Inspector Comment						
DS_ID:19879 FS_ID:34010 EP_NO: 13638 Repair Type: Non-Urgent Crossing Status: Found UCIP Comments: 04/17/2014 Need to contact owner to determine status. Crossing has been modified. (DWR UCIP - O. Magana) FIELD_STRUCT_DESC: 16-inch coated steel irrigation discharge pipe through the levee, 3.5 feet below the crown. Cutoff wall around the pipe at the center of the levee. Pump on the waterside (WS). Siphon breaker on the landside (LS) shoulder. Intake trench on the WS. (Plans to install a pump with a 16-inch pipeline over the levee authorized under Permit No. 13638, 1983 - Hamonds Ranch). [Additional Reference(s): DWR Levee Log, 2002]. FS Date: 4/17/2014

Overview of levee crown at crossing.

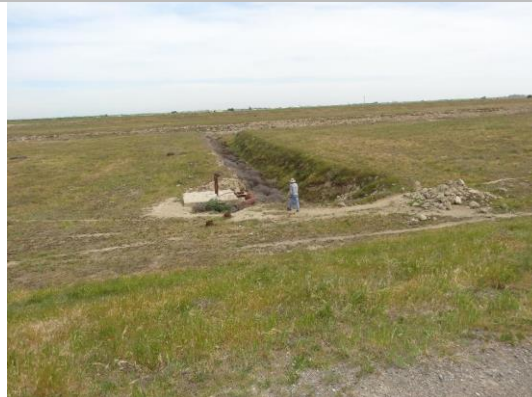
Photo 2 of 3 : UCIP_SP_2020_34010_61870.jpg

View of waterward side.

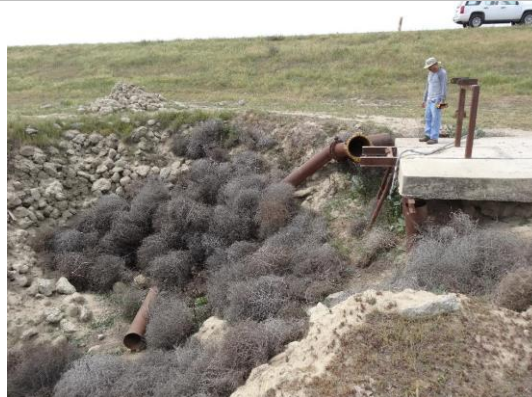
Photo 3 of 3 : UCIP_SP_2020_34010_61875.jpg

Concrete pad with abandoned support frame located on waterward side.

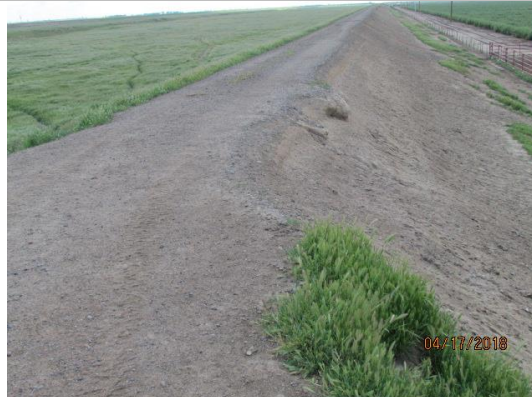
Photo 1 of 1 : SP_2020_NA0010_124_5_20200225_00007.jpg

LM Start	24.51	Rating **	U	Issue No.	5
LM End	25.01	Issue Type +	Ma	Location *	LS
Category	Earthen Levee			GPS Latitude/Longitude	
				Start	End
Item	Animal Control			37.072048 °	37.066501 °
				-120.520180 °	-120.514193 °
DWR ID	DWR_NA0010_06_s_2012_5				
Comment Code					
A2 : Repair the levee slope damaged by livestock and prevent large animal access.					
Inspector Comment					
Landside erosion and slope instability caused by livestock extends into levee crown. At the worst locations erosion extends 2.5 feet to 3 feet from the shoulder into the crown.

Looking north at livestock erosion into landward shoulder. (Spring 2018)

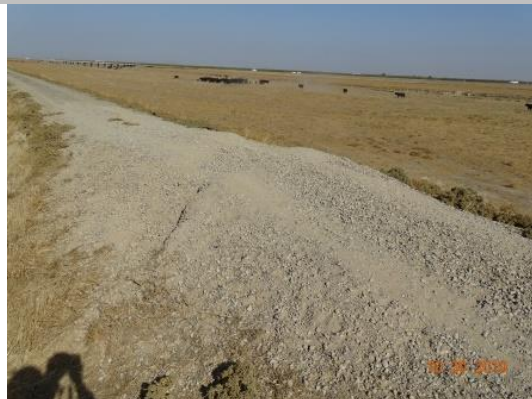
Photo 1 of 2 : SP_2020_NA0010_124_83_20200225_00029.jpg

LM Start	24.98	Rating **	A/W	Issue No.	83
LM End	24.98	Issue Type +	En	Location *	CR
Category	Earthen Levee			GPS Latitude/Longitude	
				Start	End
Item	Encroachments			37.066893 °	37.066893 °
				-120.514623 °	-120.514623 °
DWR ID	DWR_NA0010_06_f_2017_83				
Comment Code					
PI : Pipe					
Inspector Comment					
Temporary pipe has been removed but the material used to ramp over the pipe was left on the levee crown.

View of material left on levee crown used to ramp over the temporary pipe. (Fall 2019)

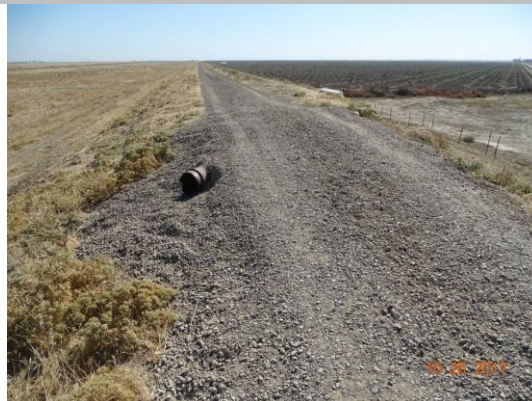
Photo 2 of 2 : SP_2020_NA0010_124_83_20200225_00030.jpg

Looking southeast at the pipe on the levee crown. (Fall 2017)

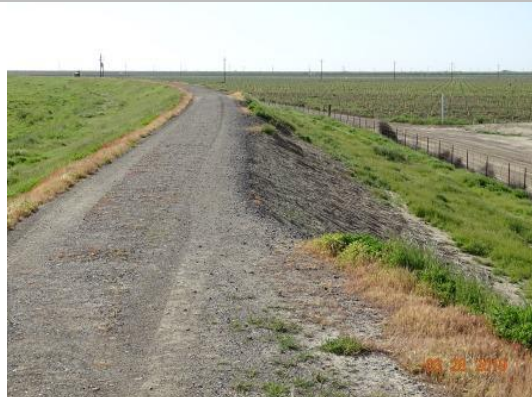
Photo 1 of 1 : SP_2020_NA0010_124_3_20200225_00003.jpg

LM Start	27.43	Rating **	M	Issue No.	3
LM End	27.99	Issue Type +	Ma	Location *	LS
Category	Earthen Levee			GPS Latitude/Longitude	
				Start	End
Item	Animal Control			37.036955 °	37.032762 °
				-120.484395 °	-120.481078 °
DWR ID	DWR_NA0010_06_s_2012_3				
Comment Code					
A2 : Repair the levee slope damaged by livestock and prevent large animal access.					
Inspector Comment					
Landside erosion and slope instability caused by livestock. Erosion greater than 3" in depth on landside slope. Levee crown has narrowed within this reach.

Looking south along landside slope. (Spring 2019)
